Addendum No. 2
TO WILSONVILLE POLICE/PUBLIC WORKS SRGP
SEIMIC IMPROVEMENT PROJECT
CONTRACT DOCUMENTS, PROJECT PLANS AND SPECIFICATIONS

REPORT OF GEOTECHNICAL ENGINEERING SERVICES

City of Wilsonville - Police/Public Works Building
30000 Town Center Loop East
Wilsonville, Oregon

HAZARDOUS MATERIALS SURVEY

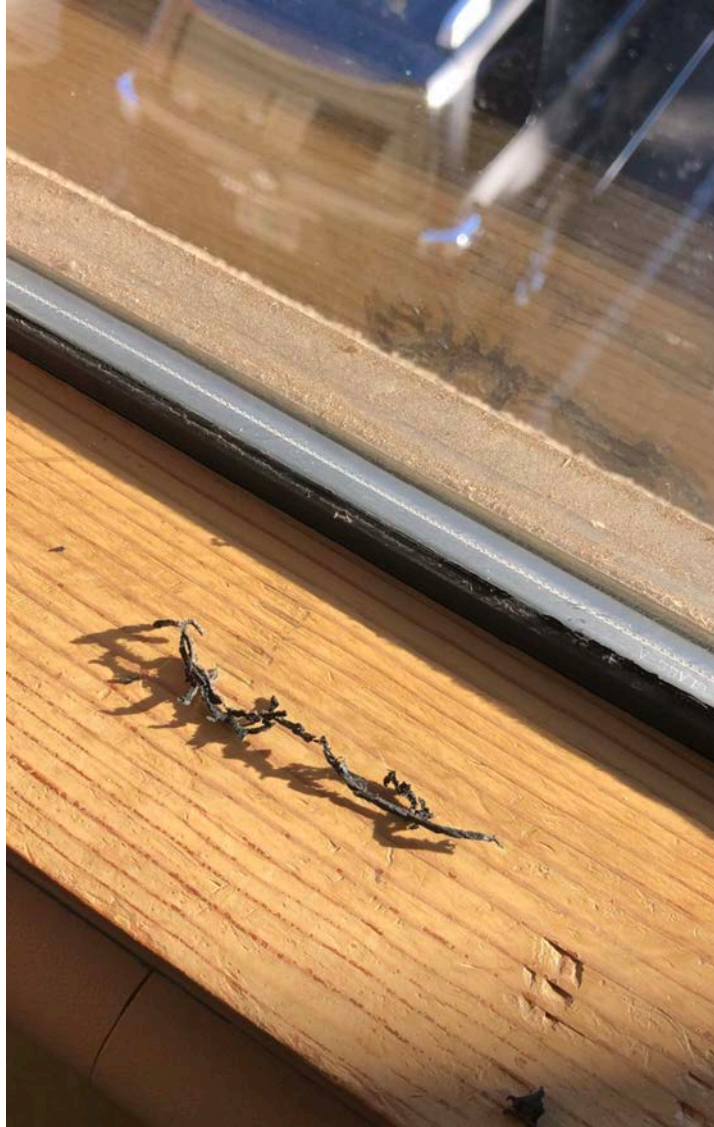
Asbestos containing window caulk
