# WETLAND DETERMINATION MEMO

DATE: April 2022

PROJECT: I-5 Bicycle and Pedestrian Bridge Project  
City of Wilsonville Project #4202  
DOWL #0256-0042

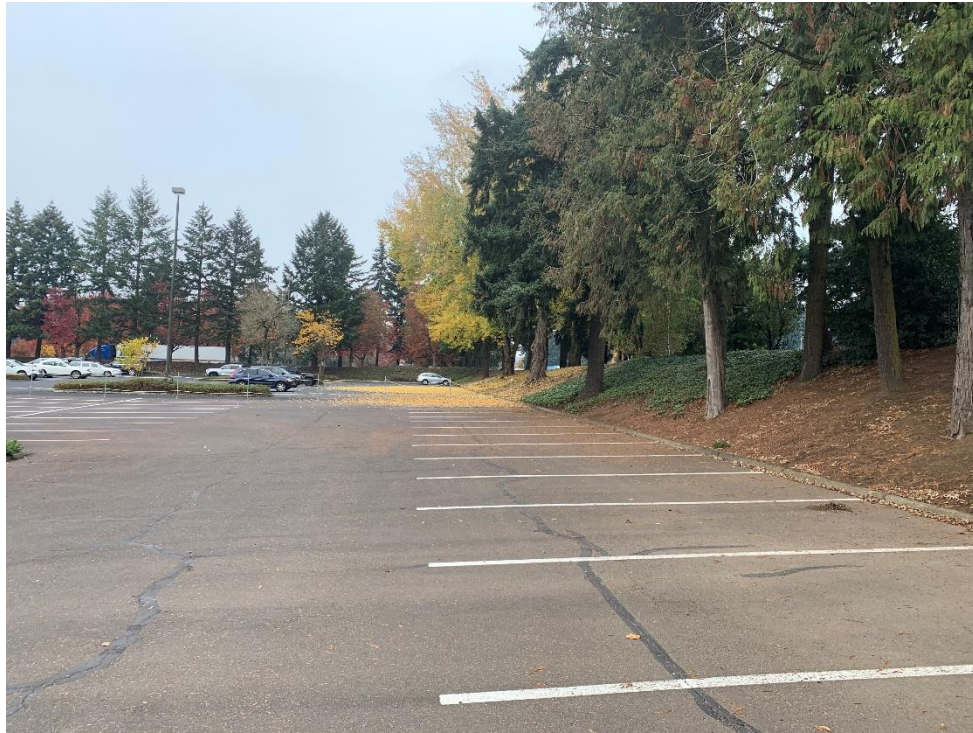
**Photograph 1:** Looking north at the westernmost parking lot within the study area in Wilsonville, Clackamas County, Oregon (November 9, 2020).

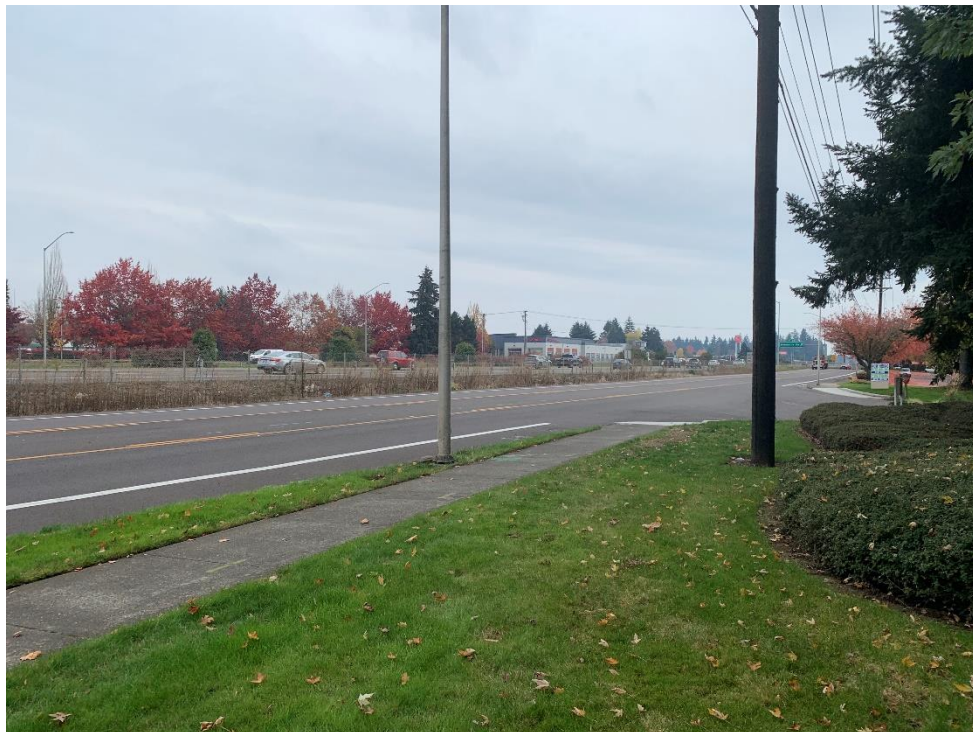
**Photograph 2:** View looking southeast at SW Boones Ferry Rd and I-5. The study area primarily consists of improved roadway surfaces, impervious parking lots, landscaped frontages and medians, and typical roadside vegetation community. (November 9, 2020).

The study area is primarily comprised of improved roadway surfaces, impervious parking lots, landscaped frontages and medians, and a typical roadside vegetation community.

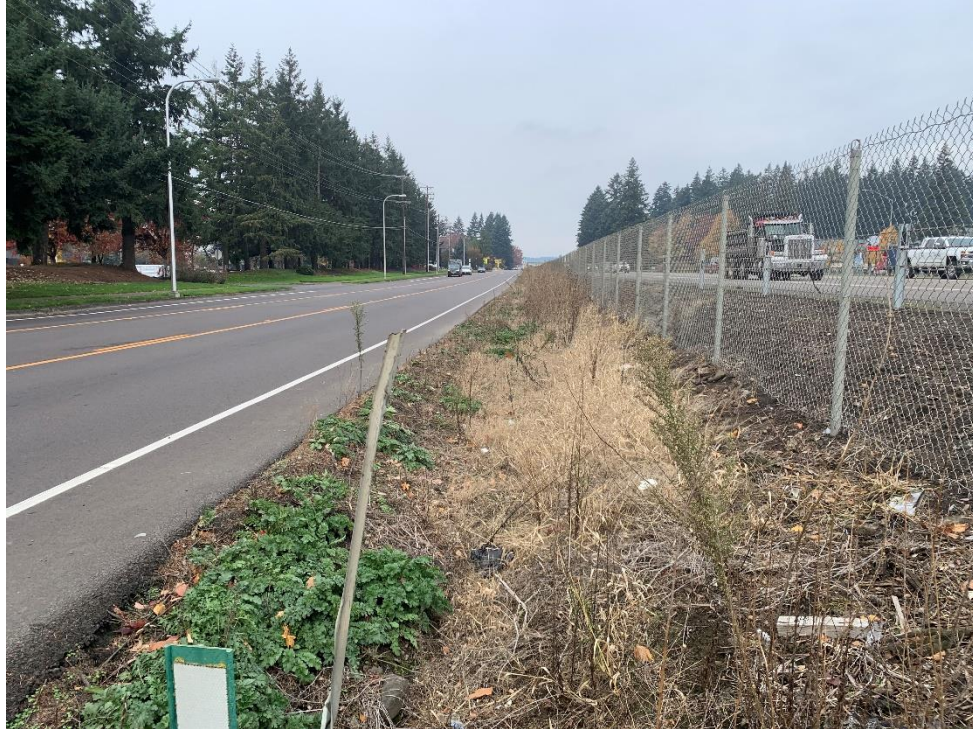
**Photograph 3:** View looking north at roadside vegetation between SW Boones Ferry Road and I-5. A typical roadside vegetation community consisting of non-native, upland weedy species (November 9, 2020).

Roadside areas consist of weedy upland plant communities dominated by *Daucus carota*, *Dipsacus sp.*, *Hypochaeris radicata*, *Geranium molle*, *Lactuca serriola*, *Jacobaea vulgaris*, and European lawn grasses. Landscaped areas include non-native trees, shrubs, and European lawn grasses. The project length is approximately 1,150 linear feet.

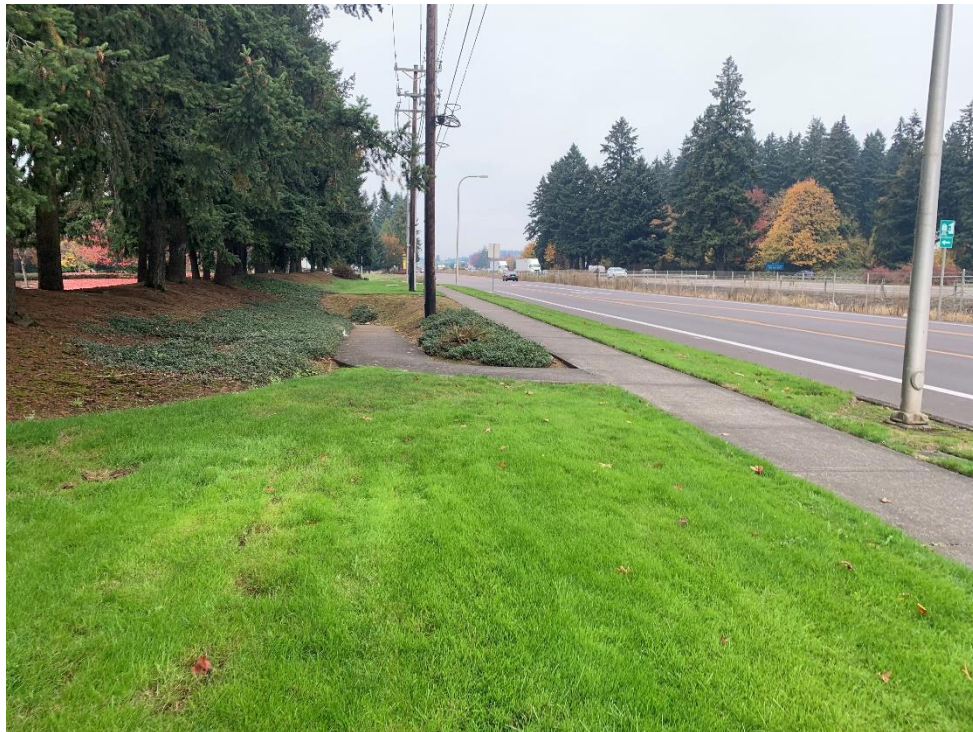
**Photograph 4:** View looking north at maintained landscaped areas in study area west of SW Boones Ferry Road. (November 9, 2020).

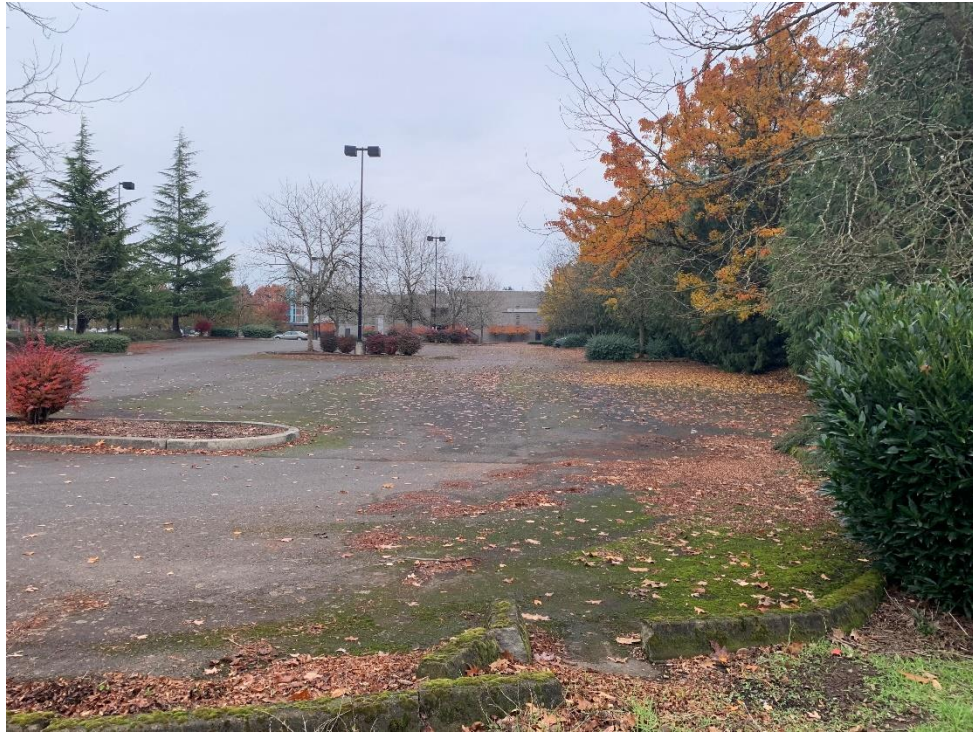
**Photograph 5:** Parking lot area within eastern portion of study area with maintained landscape features (November 9, 2020).

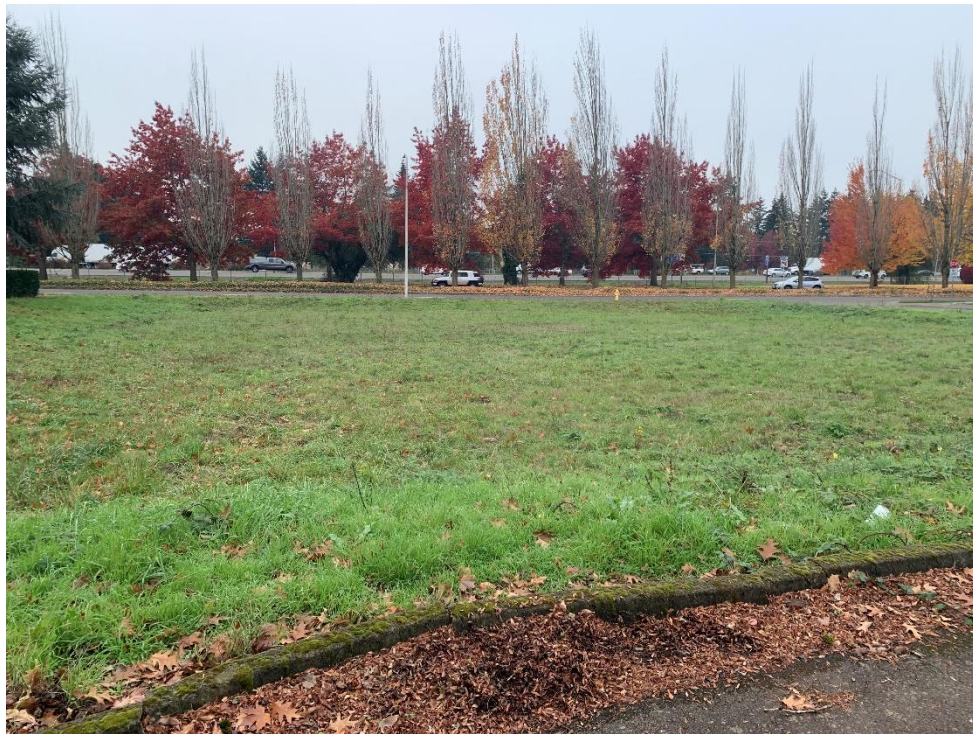
**Photograph 6:** View looking west at undeveloped lawn area adjacent to Town Center Loop W within the study area (November 9, 2020).

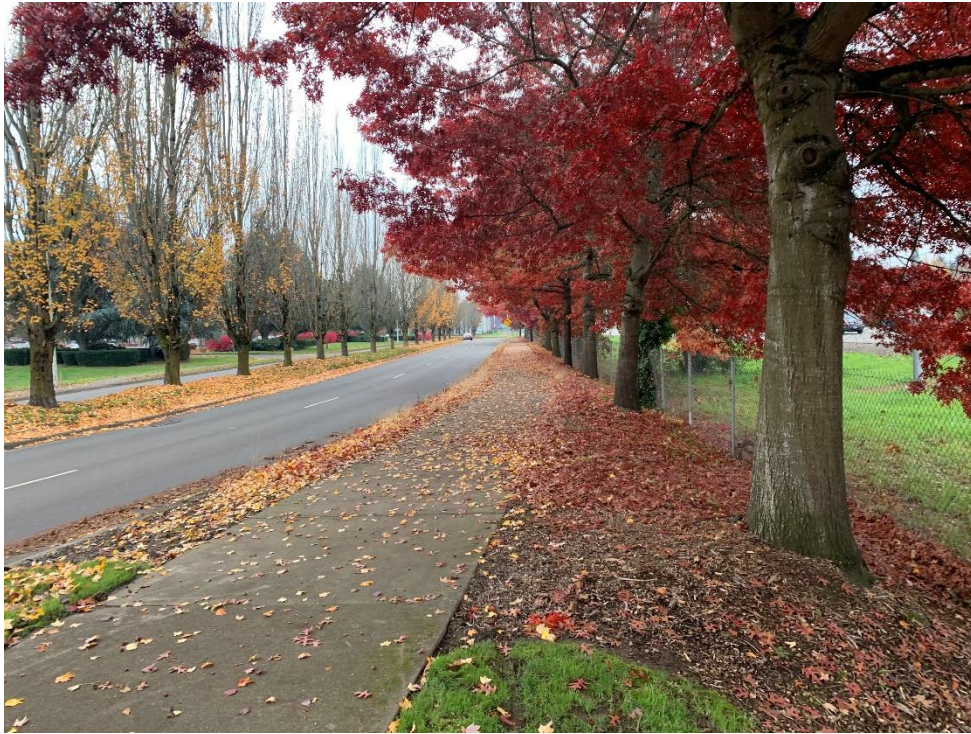
**Photograph 7:** Looking south at maintained area adjacent to Town Center Loop W (November 9, 2020).

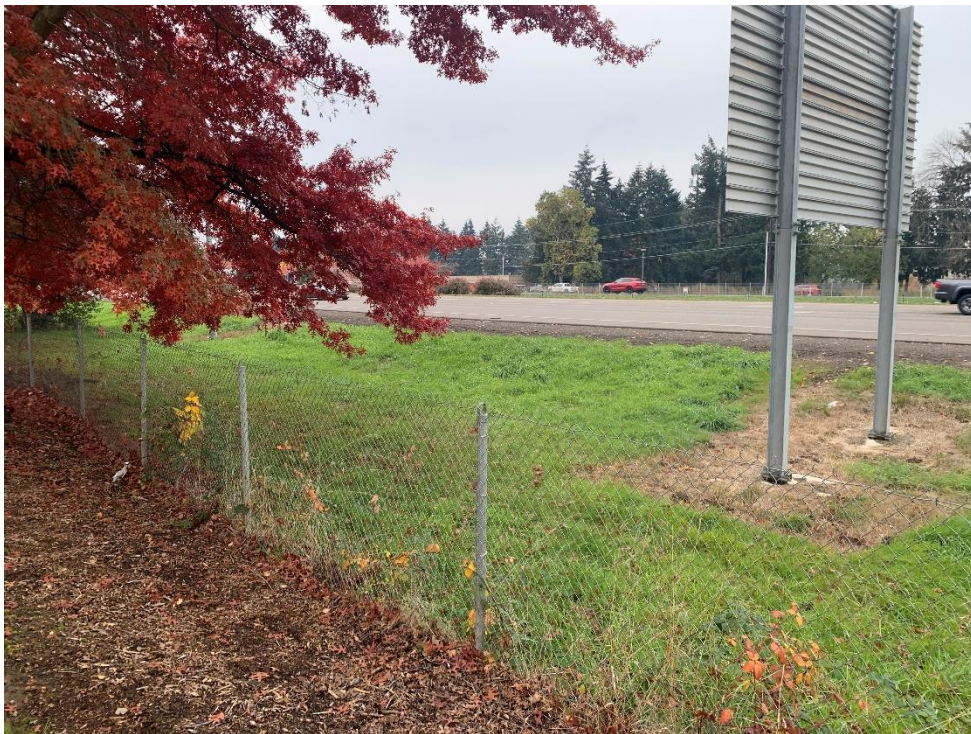
**Photograph 8:** looking southwest at I-5 ROW consisting of mowed grasses and non-native weedy, upland forbs (November 9, 2020).

The median between the northbound and southbound lanes of I-5 were visually observed from outside the ROW, from vehicles driving on the interstate, and by reviewing Google Earth imagery due to safety concerns and limited access on I-5. No evidence of flowing water, ordinary high water (OHW) markings, discoloration on historic aerial imagery, or defined bed or channel were observed in the median. Planted shrubs, a metal fence, and upland weeds were

observed at the lowest point of median. The median is dominated by mowed, non-native, weedy grasses and upland vegetation including, but not limited to, *Taraxacum officinale*, *D. carota*, and *H. radicata*.

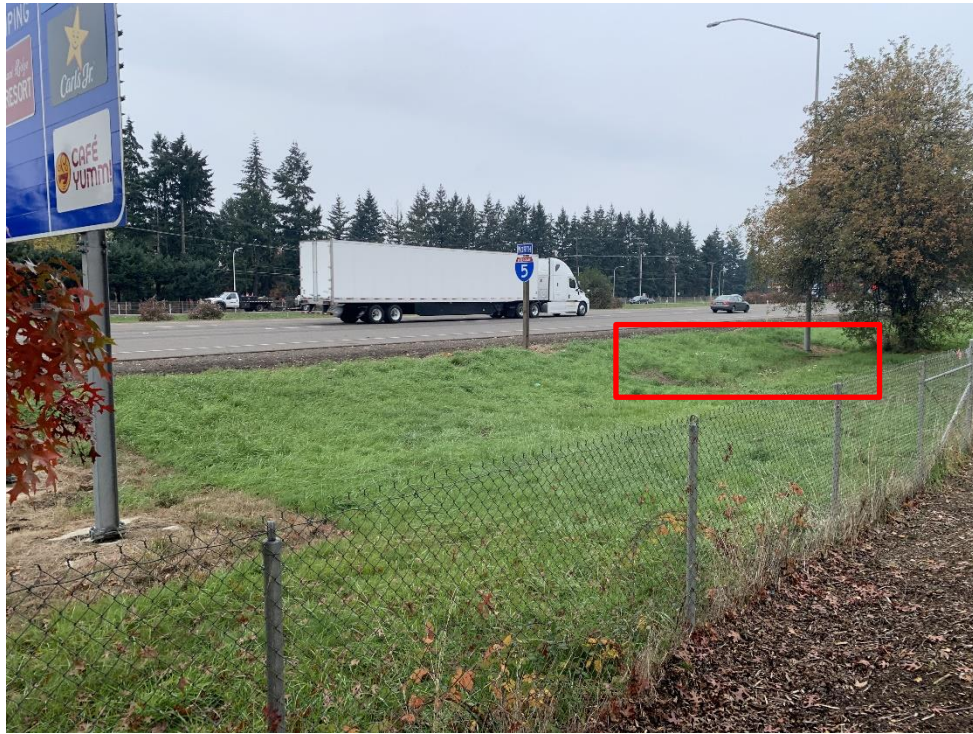
**Photograph 9:** Looking north outside of study area in ROW. Area with potential drainage and potential wetland north of the study area (November 9, 2020).

No potential wetland areas were identified in the study area during the reconnaissance. However, one drainage and potential wetland area are present approximately twenty feet north of the northeast corner of the study area (see Wetland Determination Map; Attachment A). Impacts to the drainage and potential wetland area are not anticipated but should be avoided. The findings of the field investigation are consistent with the NWI and LWI maps as no evidence of wetlands or waters were observed within the study area.
