West Hills Land Development: Frog Pond Meadows Residential Development

# Wetland Delineation Report

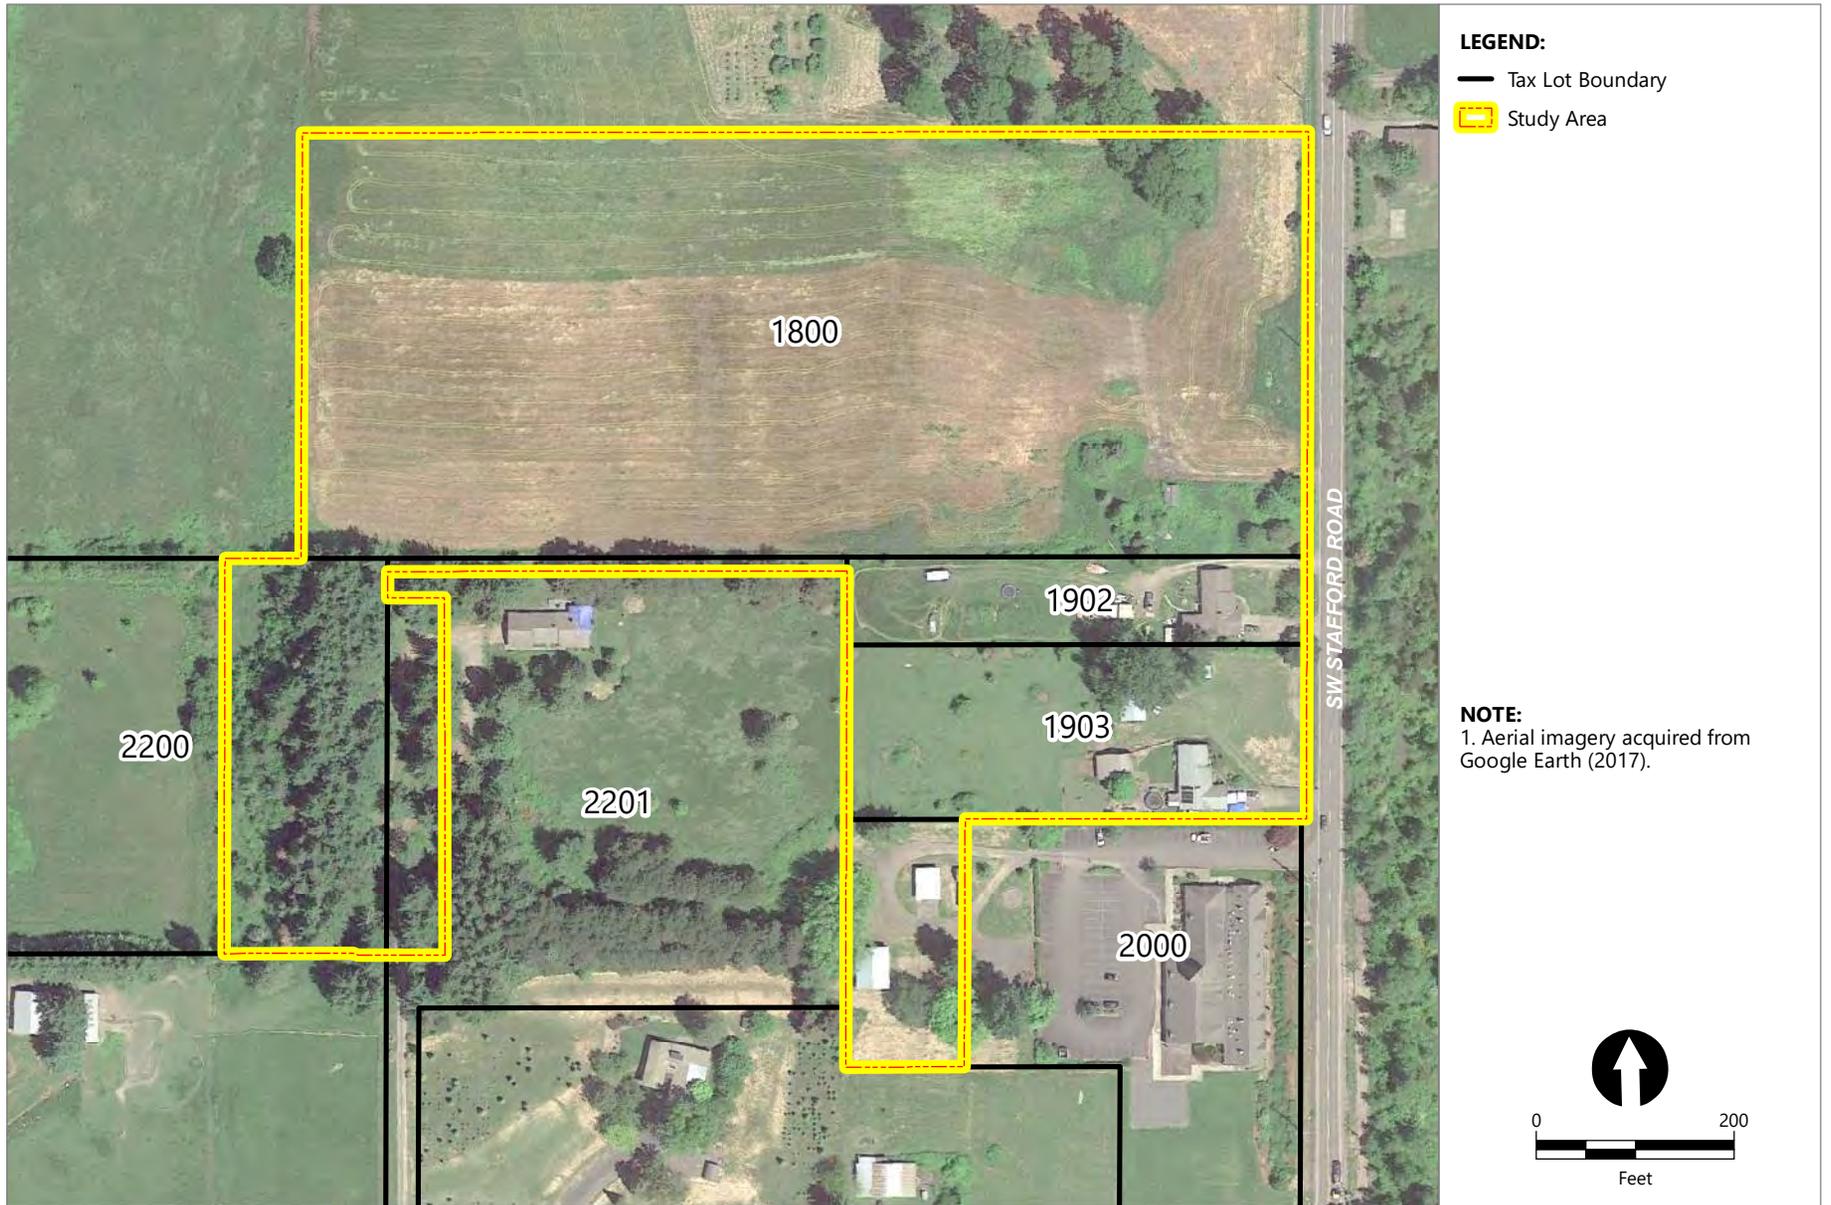
**Figure 4**  
**2017 Aerial Overview Map**  
 Wetland Delineation Report

The current conditions of the study area are depicted in the 2017 aerial photograph provided in Figure 4. The predominant land use and existing structures for each of the properties and parcels contained within the study area are briefly described in the following sections:

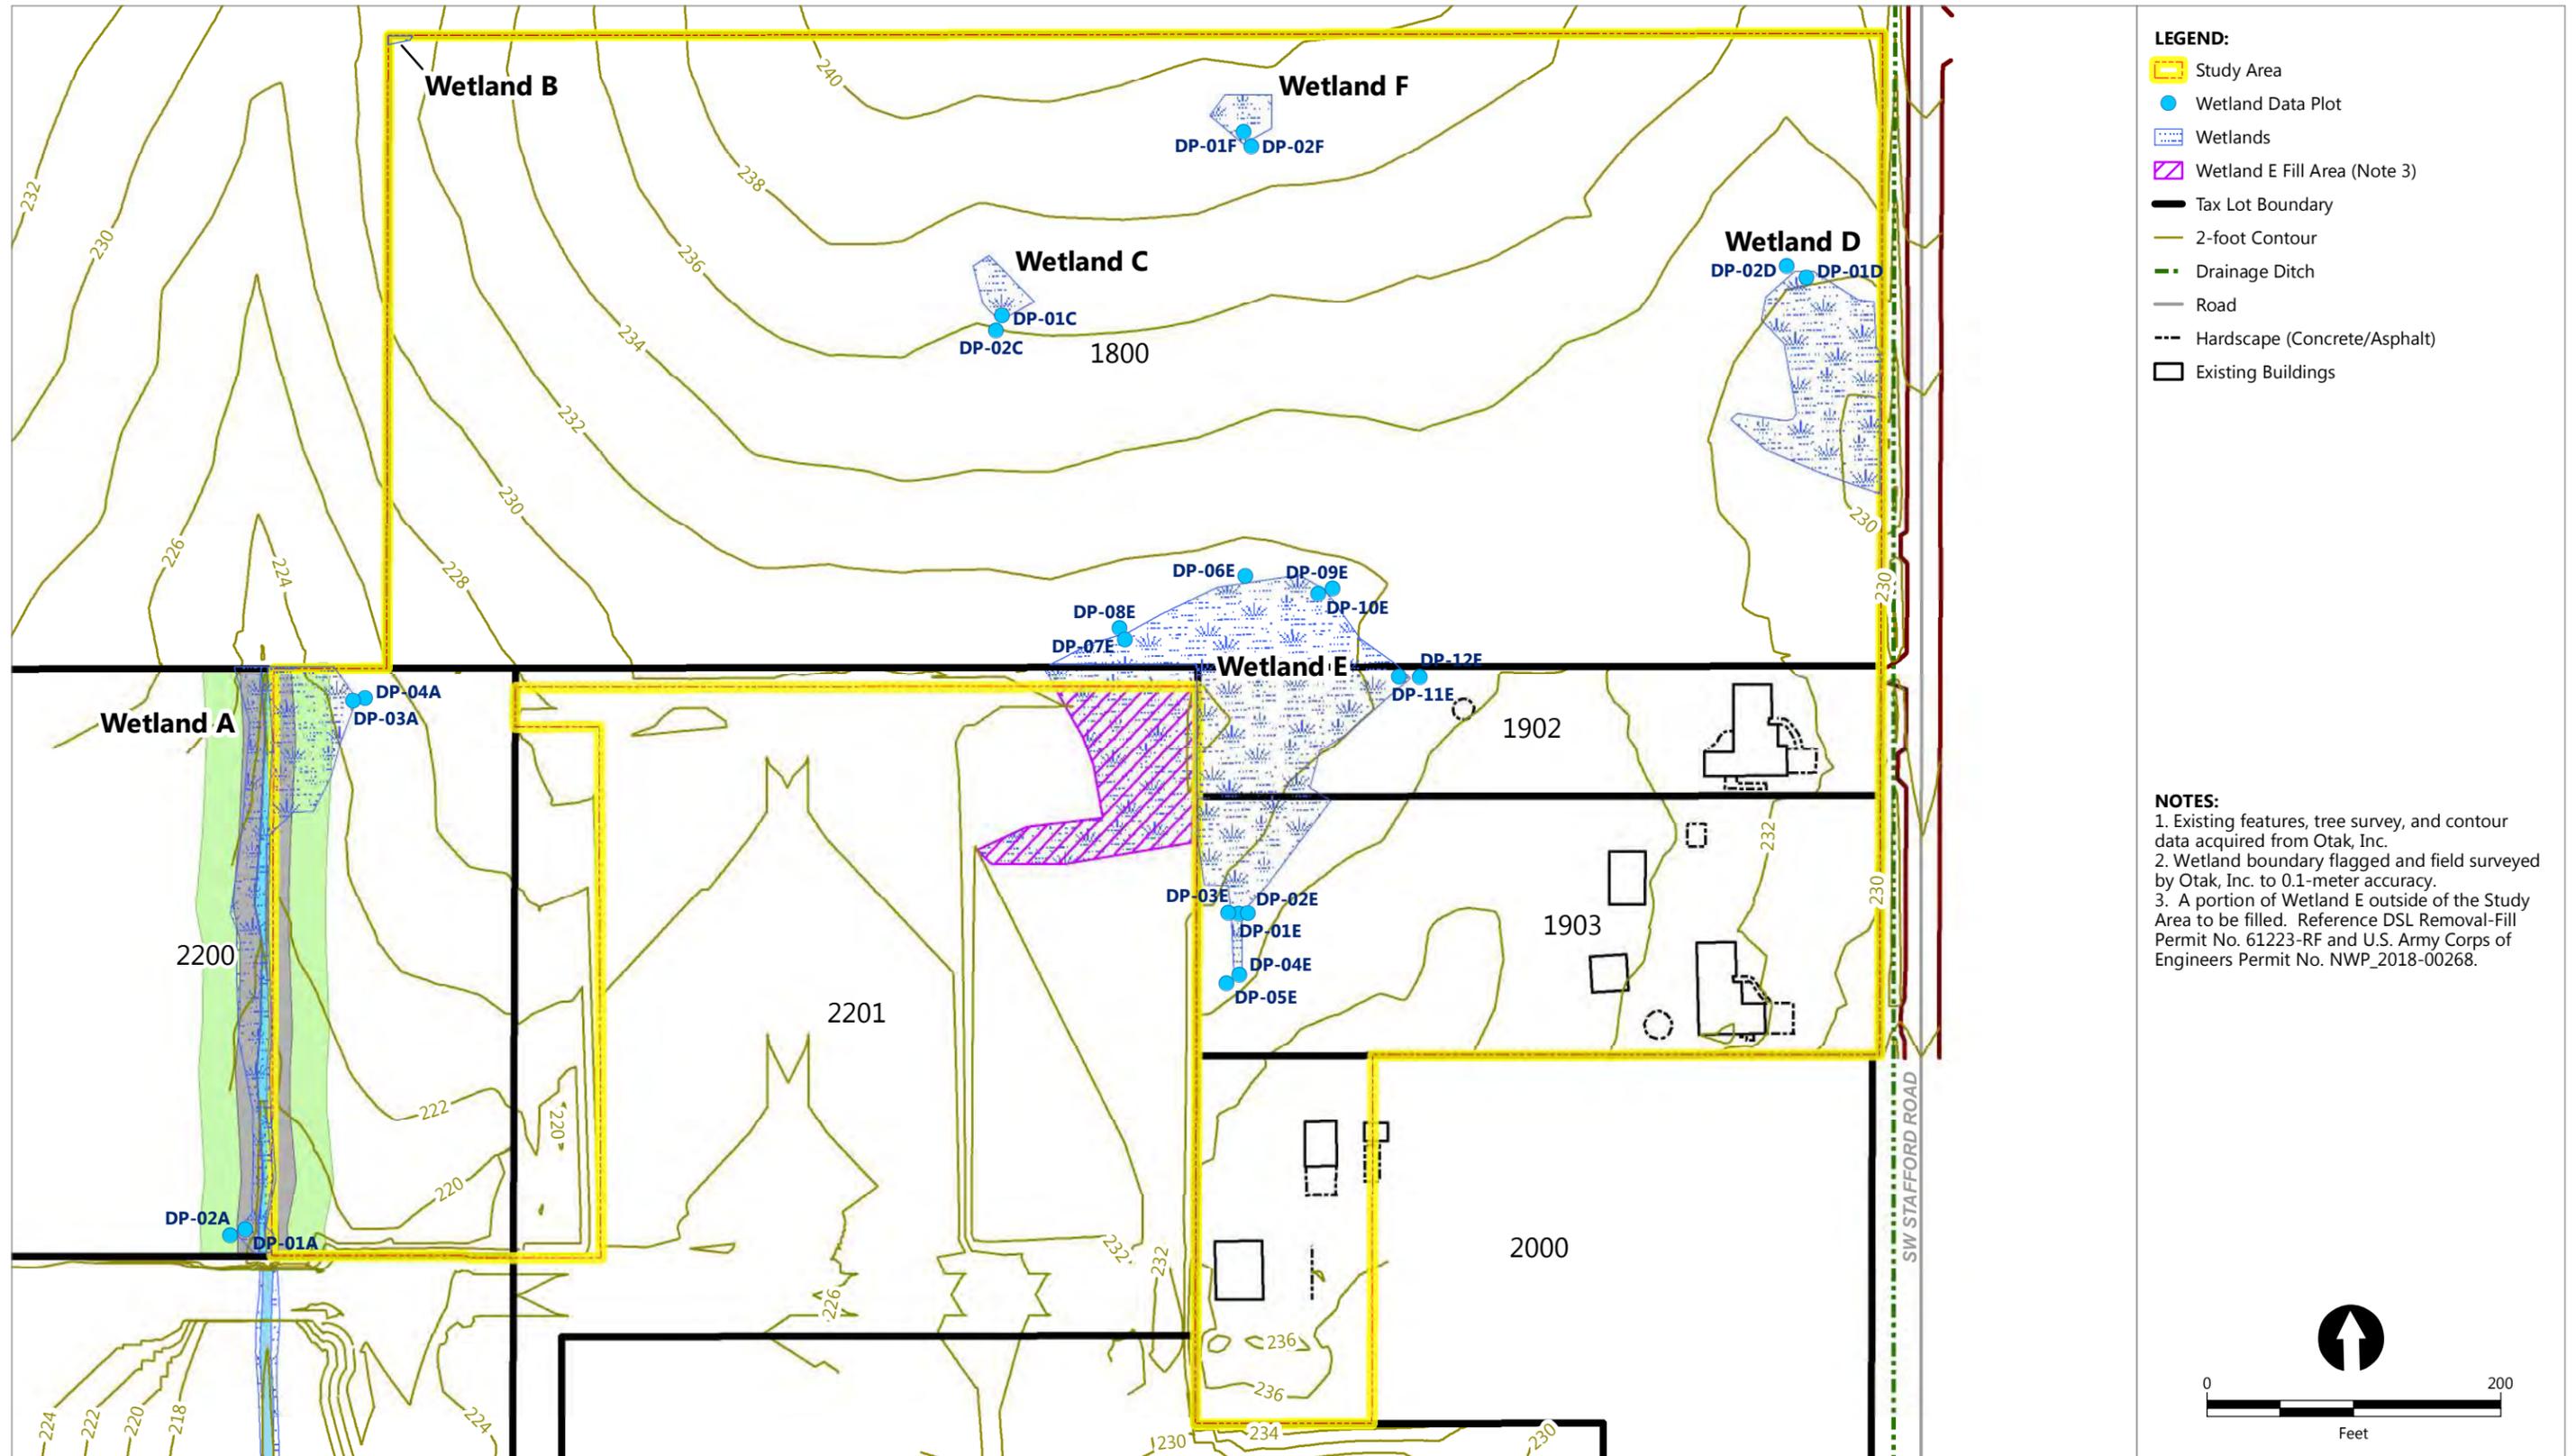
**Figure 10**  
**Overview Map**

Data Plot 01A (DP-01A) is located along the off-site southwestern boundary of Wetland A (Figures 10 and 11a). Two distinct layers were observed in the soil profile, with the uppermost layer extending to 4 inches below ground surface (bgs) and the second layer extending from 4 to 16 inches bgs. The matrix color observed in the upper layer was 10YR 3/2 (very dark grayish brown) with 2% and 3% 7.5YR 5/6 (strong brown) redoximorphic concentrations along pore linings (i.e., oxidized rhizospheres along living roots) and in the matrix, respectively. The second layer exhibited the same matrix color but had 2% and 10% 7.5YR 5/6 (strong brown) redoximorphic concentrations along pore linings and in the matrix, and 5% 5YR 3/4 (dark reddish brown) redoximorphic concentrations in the matrix. The soil sample met the Depleted Matrix (F3) and Redox Dark Surface (F6) hydric soil indicators, satisfying the hydric soil criteria of the 2010 Regional Supplement and *Field Indicators of Hydric Soils in the United States, Version 8.1, 2017* (USDA and NRCS 2016).

DP-03A is located along the northeastern boundary of Wetland A (Figures 10 and 11a). Four distinct layers were noted in the soil profile, with the uppermost layer extending to 3 inches bgs, the second layer extending from 3 to 6 inches bgs, the third layer extending from 6 to 12 inches bgs, and the fourth layer extending from 12 to 16 inches bgs. The matrix color observed in the upper layer was 10YR 3/2 (very dark grayish brown) with no evidence of redoximorphic concentrations. The second layer exhibited the same matrix color but had 5% 7.5YR 5/6 (strong brown) redoximorphic concentrations in the matrix. The third layer also had the same color matrix but included 5% 5YR 5/6

DP-01B is located within an off-site portion of Wetland B (Figures 10 and 11b). Four distinct layers were noted in the soil profile, with the uppermost layer extending to 2 inches bgs, the second layer extending from 2 to 5 inches bgs, the third layer extending from 5 to 12 inches bgs, and the fourth layer extending from 12 to 16 inches bgs. The matrix color observed in the upper layer was 10YR 3/3 (dark brown) with no evidence of redoximorphic concentrations. The second layer exhibited a matrix color of 10YR 4/2 (dark grayish brown) with 2% 5YR 5/6 (yellowish red) redoximorphic concentrations along pore linings and 10% redoximorphic concentrations of the same color in the matrix. The third layer had the same matrix and redoximorphic concentration colors as the second layer but had 5% of the concentrations around pore linings and 15% of the concentrations in the matrix. In the fourth layer, the matrix color changed to 10YR 4/1 (dark gray) with 5% 5YR 5/6 (yellowish red) redoximorphic concentrations along pore linings and 25% redoximorphic concentrations of the same color in the matrix. The DP-01B soil sample met the Depleted Matrix (F3) hydric soil indicator, satisfying the hydric soil criteria of the 2010 Regional Supplement and *Field Indicators of Hydric Soils in the United States, Version 8.1, 2017* (USDA and NRCS 2016).

DP-01C is located in the southern portion of Wetland C (Figures 10, 11b, and 11c). Four distinct layers were noted in the soil profile, with the uppermost layer extending to 2 inches bgs, the second layer extending from 2 to 6 inches bgs, the third layer extending from 6 to 12 inches bgs, and the fourth layer extending from 12 to 16 inches bgs. The matrix color observed in the upper layer was 10YR 4/2 (dark grayish brown) with no evidence of redoximorphic concentrations. The second layer exhibited a matrix color of 10YR 4/2 (dark grayish brown) with 2% 7.5YR 5/6 (strong brown) redoximorphic concentrations along pore linings and 5% redoximorphic concentrations of the same color in the matrix. The third layer had a gleyed matrix color of N 4/0 (dark gray) with 5% 2.5YR 4/6 (red) redoximorphic concentrations along pore linings and 15% redoximorphic concentrations of the same color in the matrix. In the fourth layer, the matrix color changed to 10YR 4/1 (dark gray) with 10% 7.5YR 5/6 (strong brown) redoximorphic concentrations and 20% 10YR 5/2 (grayish brown) in the matrix. The DP-01C soil sample met the Loamy Gleyed Matrix (F2) and Depleted Matrix (F3) hydric soil indicators, satisfying the hydric soil criteria of the 2010 Regional Supplement and *Field Indicators of Hydric Soils in the United States, Version 8.1, 2017* (USDA and NRCS 2016).

DP-01D is located in the northern portion of Wetland D (Figures 10 and 11c). Four distinct layers were noted in the soil profile, with the uppermost layer extending to 4 inches bgs, the second layer extending from 4 to 10 inches bgs, the third layer extending from 10 to 12 inches bgs, and the fourth layer extending from 12 to 16 inches bgs. The matrix color observed in the upper layer was 10YR 3/2 (very dark grayish brown) with no evidence of redoximorphic concentrations. The second layer exhibited the same matrix color but had 2% 7.5YR 6/6 (reddish yellow) redoximorphic concentrations along pore linings and 5% 7.5YR 5/4 (brown) redoximorphic concentrations in the matrix. The third layer had a matrix color of 10YR 4/2 (dark grayish brown) with a mix of 5% 2.5YR 4/6 (red) and 15% 7.5YR 4/6 (dark yellowish brown) redoximorphic concentrations in the matrix. In the fourth layer, the matrix color remained the same but the redoximorphic features changed to 15% 7.5YR 4/4 (dark yellowish brown) in the matrix. The DP-01D soil sample met the Redox Dark Surface (F6) hydric soil indicators, satisfying the hydric soil criteria of the 2010 Regional Supplement and *Field Indicators of Hydric Soils in the United States, Version 8.1, 2017* (USDA and NRCS 2016).

DP-01E is located in the southern portion of Wetland E (Figures 10 and 11d). Three distinct layers were observed in the soil profile, with the uppermost layer extending to 7 inches bgs, the second layer extending from 7 to 12 inches bgs, and the third layer extending from 12 to 16 inches bgs. The matrix color observed in the upper layer was 7.5YR 3/2 (dark brown) with 5% 5YR 5/6 (yellowish red) redoximorphic concentrations along pore linings and 5% 5YR 5/6 (yellowish red) redoximorphic concentrations in the matrix. The second layer had a matrix color of 7.5YR 4/2 (brown) with a variety of redoximorphic concentrations occurring in the matrix. Concentration colors included 5% 5YR 4/4 (reddish brown), 5% 5YR 5/6 (yellowish red), and 2% 5YR 3/3 (dark reddish brown). The third layer had a matrix color of 7.5YR 5/2 (brown) with no redoximorphic features present. The DP-01E soil sample met the Depleted Matrix (F3) and Redox Dark Surface (F6) hydric soil indicators, satisfying the hydric soil criteria of the 2010 Regional Supplement and *Field Indicators of Hydric Soils in the United States, Version 8.1, 2017* (USDA and NRCS 2016).

DP-04E is located in the southernmost portion of Wetland E (Figures 10 and 11d). Three distinct layers were observed in the soil profile, with the uppermost layer extending to 3 inches bgs, the second layer extending from 3 to 7 inches bgs, and the third layer extending from 7 to 16 inches bgs. The matrix color observed in the upper layer was 7.5YR 3/2 (dark brown) with no redoximorphic concentrations present. The second layer had a matrix color of 7.5YR 4/2 (brown) with 5% 5YR 5/6 (yellowish red) redoximorphic concentrations along pore linings and 5% 5YR 5/6 (yellowish red) redoximorphic concentrations in the matrix. The third layer had a matrix color of 7.5YR 5/2 (brown) and both 5% 5YR 3/4 (dark reddish brown) and 20% 7.5YR 5/6 (strong brown) redoximorphic concentrations in the matrix. The DP-04E soil sample met the Depleted Matrix (F3) hydric soil indicator, satisfying the hydric soil criteria of the 2010 Regional Supplement and *Field Indicators of Hydric Soils in the United States, Version 8.1, 2017* (USDA and NRCS 2016).

DP-07E is located in the western portion of Wetland E (Figures 10, 11b, and 11c). Four distinct layers were observed in the soil profile, with the uppermost layer extending to 2 inches bgs, the second layer extending from 2 to 6 inches bgs, the third layer extending from 6 to 12 inches bgs, and the lowermost layer extending from 12 to 16 bgs. The matrix color observed in the upper layer was 10YR 4/2 (dark grayish brown) with no redoximorphic concentrations present. The second layer had the same matrix color but included 2% 7.5YR 5/6 (strong brown) redoximorphic concentrations along pore linings and 5% 7.5YR 5/6 (strong brown) redoximorphic concentrations in the matrix. The third layer had a matrix color of 10YR 4/1 (dark gray) with 10% 5YR 4/6 (yellowish red) redoximorphic concentrations along pore linings and 5% 2.5YR 3/6 (dark red) concentrations in the matrix. The fourth layer exhibited a mixed matrix of 40% 10YR 4/1 (dark gray) and 40% 10YR 5/1 (gray) with 20% 7.5YR 5/6 (strong

DP-010E is located in the northern portion of Wetland E (Figures 10 and 11c). Four distinct layers were observed in the soil profile, with the uppermost layer extending to 4 inches bgs, the second layer extending from 4 to 6 inches bgs, the third layer extending from 6 to 10 inches bgs, and the lowermost layer extending from 10 to 16 bgs. The matrix color observed in the upper layer was 10YR 3/2 (very dark grayish brown) with no redoximorphic concentrations present. The second layer had the same matrix color but included 2% 7.5YR 5/6 (strong brown) redoximorphic concentrations in the matrix. The third layer had a matrix color of 10YR 3/1 (very dark gray) with 10% 2.5YR 3/6 (dark red) redoximorphic concentrations in the matrix, 2.5YR 3/6 redoximorphic concentrations along pore linings, and 5% 10YR 4/1 (dark gray) depletions in the matrix. The fourth layer exhibited a matrix color of 10YR 4/1 with 15% 5YR 5/6 (yellowish red) redoximorphic concentrations in the matrix, 1% 5YR 5/6 redoximorphic concentrations along pore linings, and 5% 10YR 5/1 (dark) depletions in the matrix. The DP-011E soil sample met the Redox Dark Surface (F6) hydric soil indicators, satisfying the hydric soil criteria of the 2010 Regional Supplement and *Field Indicators of Hydric Soils in the United States, Version 8.1, 2017* (USDA and NRCS 2016).

DP-011E is located in the eastern portion of Wetland E (Figures 10, 11c, and 11d). Four distinct layers were observed in the soil profile, with the uppermost layer extending to 4 inches bgs, the second layer extending from 4 to 7 inches bgs, the third layer extending from 7 to 12 inches bgs, and the lowermost layer extending from 12 to 16 bgs. The matrix color observed in the upper layer was 10YR 3/2 (very dark grayish brown) with no redoximorphic concentrations present. The second layer had the same matrix color but included 2% 5YR 5/6 (yellowish red) redoximorphic concentrations along pore linings and 5% 5YR 5/6 (yellowish red) redoximorphic concentrations in the matrix. The third layer had a matrix color of 10YR 4/2 (dark grayish brown) with 10% 5YR 4/4 (reddish brown) redoximorphic concentrations in the matrix. The fourth layer exhibited a matrix color of 10YR 4/1 (dark gray) with a mix of 5% 5YR 5/6 (yellowish red) and 5% 5YR 4/4 (reddish brown) redoximorphic concentrations in the matrix. The DP-011E soil sample met the Depleted Below Dark Surface (A11) and Depleted Matrix (F3) hydric soil indicators, satisfying the hydric soil criteria of the 2010 Regional Supplement and *Field Indicators of Hydric Soils in the United States, Version 8.1, 2017* (USDA and NRCS 2016).

DP-01F is located in an agricultural field in the middle of Wetland F (Figures 10, 11b, and 11c). Four distinct layers were observed in the soil profile, with the uppermost layer extending to 2 inches bgs, the second layer extending from 2 to 6 inches bgs, the third layer extending from 6 to 12 inches bgs, and the lowermost layer extending from 12 to 16 bgs. The matrix color observed in the upper layer was 10YR 4/2 (dark grayish brown) with no redoximorphic concentrations present. The second layer had the same matrix color but included 2% 7.5YR 5/6 (strong brown) redoximorphic concentrations along pore linings and 5% 7.5YR 5/6 (strong brown) redoximorphic concentrations in the matrix. The third layer had a gleyed matrix of N 4/0 (dark gray) with 5% 2.5YR 4/6 (red) redoximorphic concentrations along pore lining and 15% concentrations of the same color in the matrix. The fourth layer exhibited a matrix color of 10YR 4/1 (dark gray) with a mix of 10% 7.5YR 5/6 (strong brown) and 20% 10YR 5/2 (grayish brown) depletions in the matrix. The DP-01F soil sample

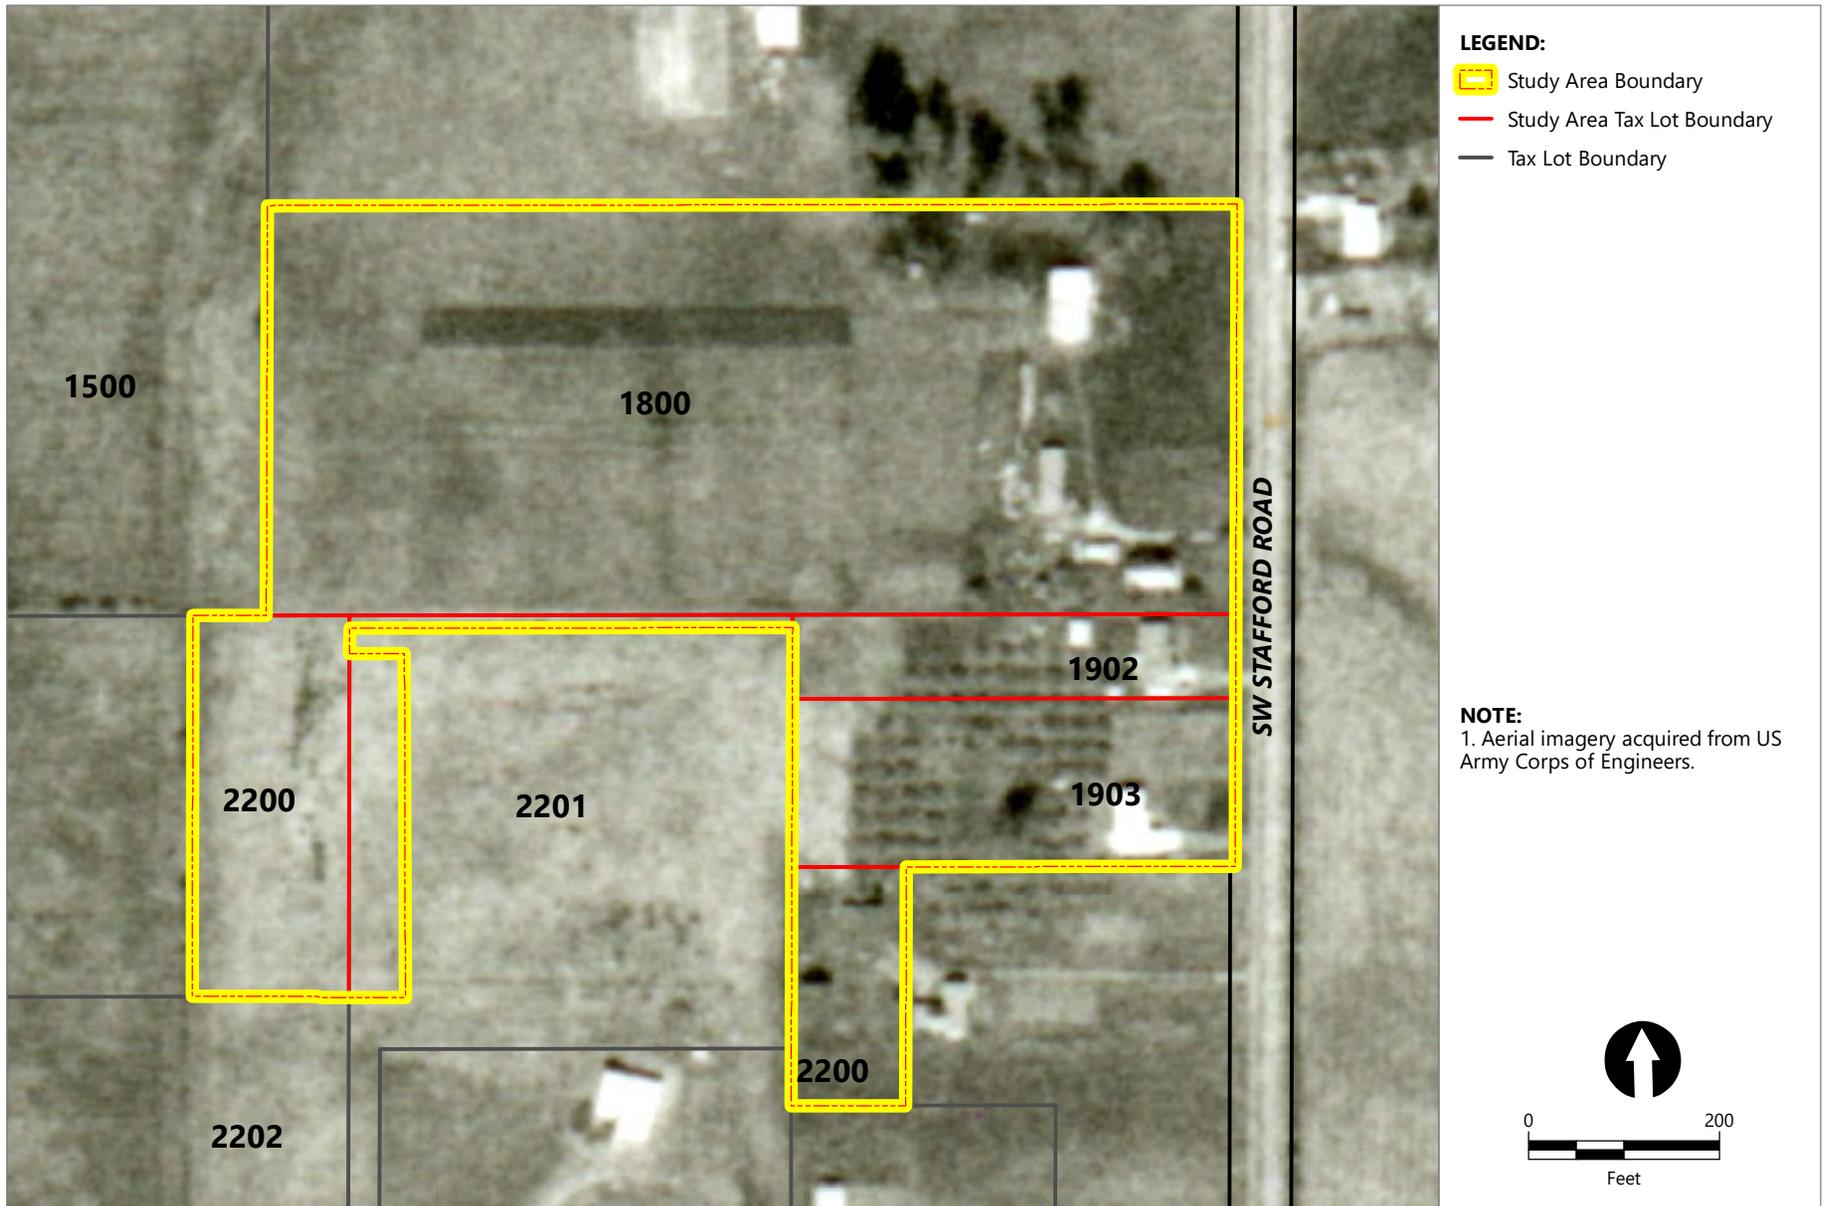
**Figure B3**  
**Historical Aerial – 1976**  
 Wetland Delineation Report

The 1976 aerial photograph (Appendix A, Photograph B3) shows that tax lots 1902, 1903, 2000, 2001, 2100, and 2202 have been divided into separate parcels. Homes have been constructed on the eastern portions of tax lots 1902 and 1903 and on off-site tax lots 2000 and 2100. Orchards remain present on the western portions of tax lots 1902 and 1903, and agricultural land use on the other properties within the study area appears the same as observed on the 1953 aerial photograph. Willow Creek is visible, but the agricultural ditch previously noted on the 1936 and 1953 aerial photographs is not apparent. Off-site drainage patterns remain similar to those shown on the 1936 and 1953 aerial photographs. Surrounding land use shows signs of changes, especially on the south

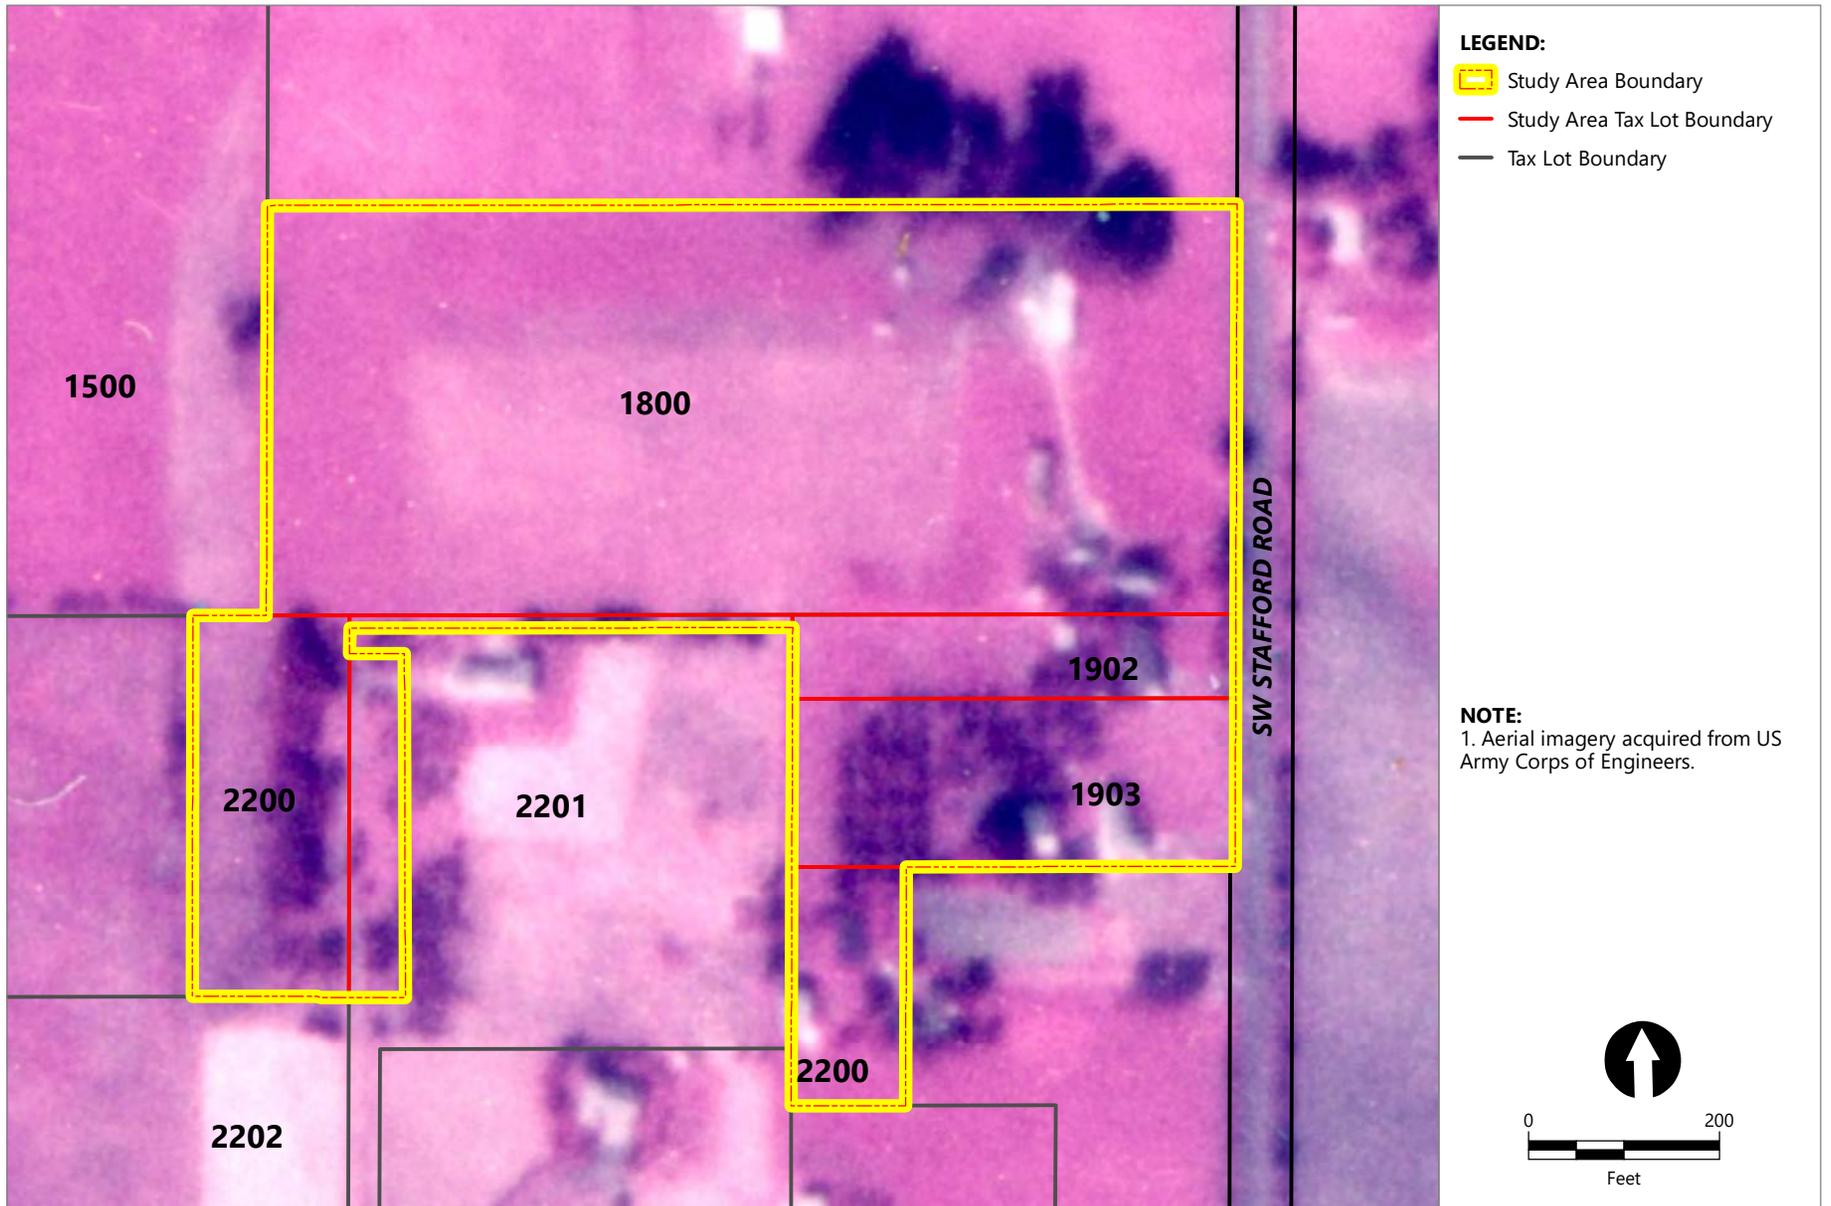
**Figure B4**  
**Historical Aerial – 1983**  
 Wetland Delineation Report

By 1983, the current configuration of tax lots in the study area and surrounding areas appears to have become established (Appendix B, Photograph B4). Cultivation on tax lot 2201 has ceased and a home constructed in its north-central portion. Areas of trees, likely planted, have developed along the northern and western boundaries of tax lot 2201 and along the eastern end of tax lot 2200. Land use on the other properties within the study area remains much the same as observed on the 1976 aerial photograph. Willow Creek is again visible, but there are no indications of the former agricultural ditch. Off-site drainage patterns remain similar to those shown on the previous aerial photographs.

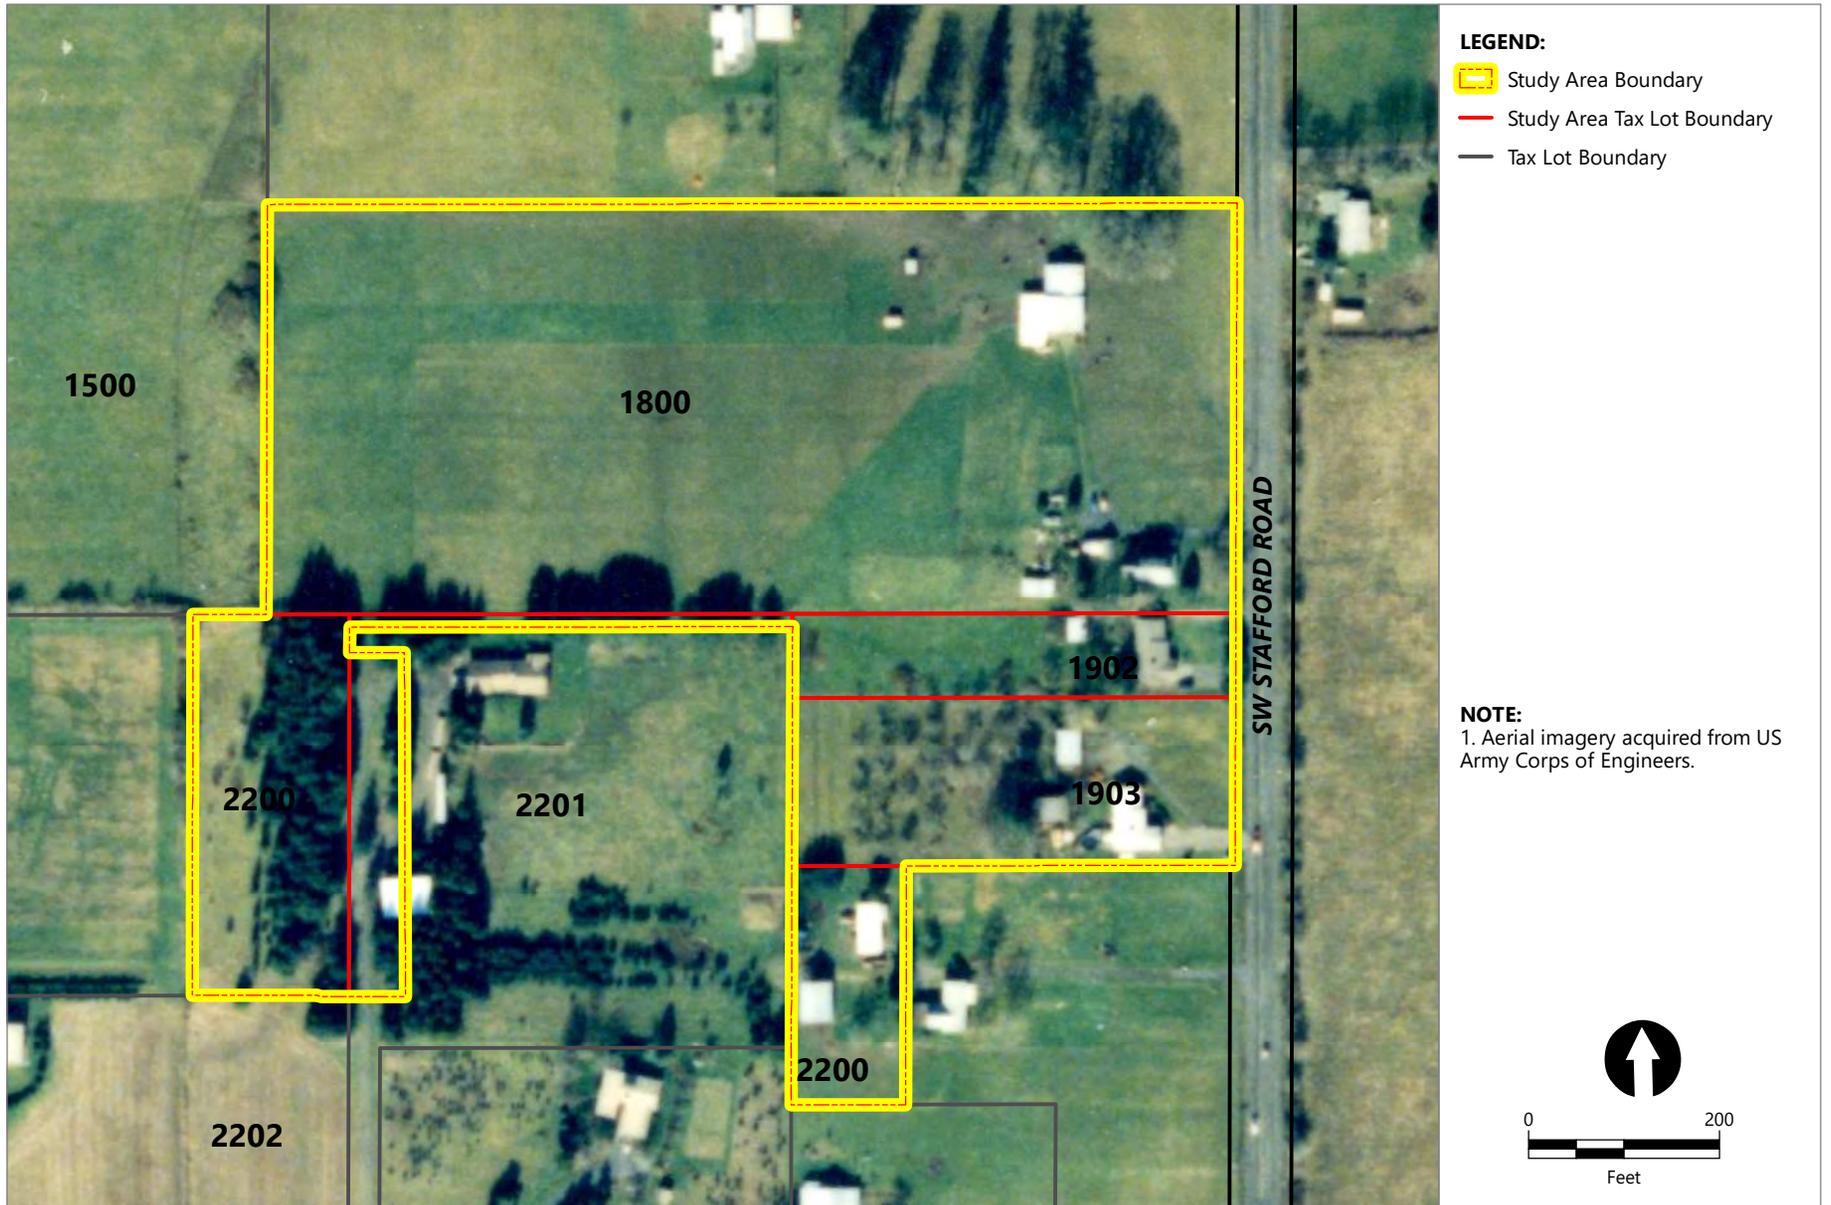
**Figure B5**  
**Historical Aerial – 1996**  
 Wetland Delineation Report

The 1996 aerial photograph (Appendix B, Photograph B5) shows additional buildings were constructed on both tax lots 2000 and 2201 between 1983 and 1996. The forested areas along the eastern end of tax lot 2200 and southwestern portion of tax lot 2201 have expanded in extent and become denser. Land use on the other parcels within the study area remains much the same as the previous years. Willow Creek appears the same as on the previous photographs; however, there are no indications of the former agricultural ditch observed on older aerial images. The off-site field to the east of SW Stafford Road appears to have been left fallow. The agricultural drainage patterns previously observed in that field remain present but are not as visible as in past years. The 1996 aerial photograph also shows that by this time, the southern portion of SW Stafford Road had been widened and realigned to its current configuration as SW Wilsonville Road. The road network for a higher density residential development had also been constructed around this new road on the south side of SW Boeckman Road/SW Advance Road.

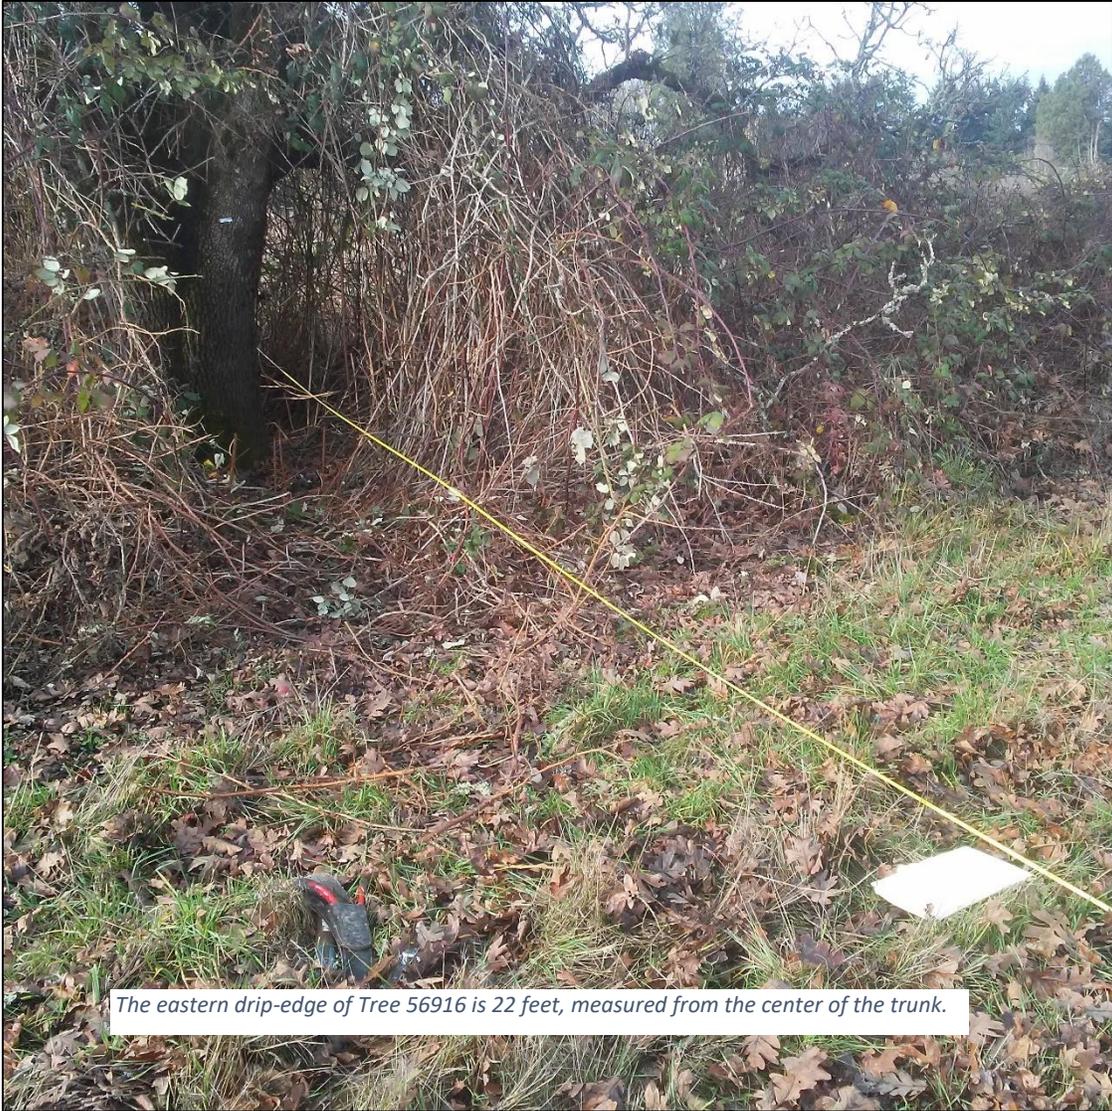
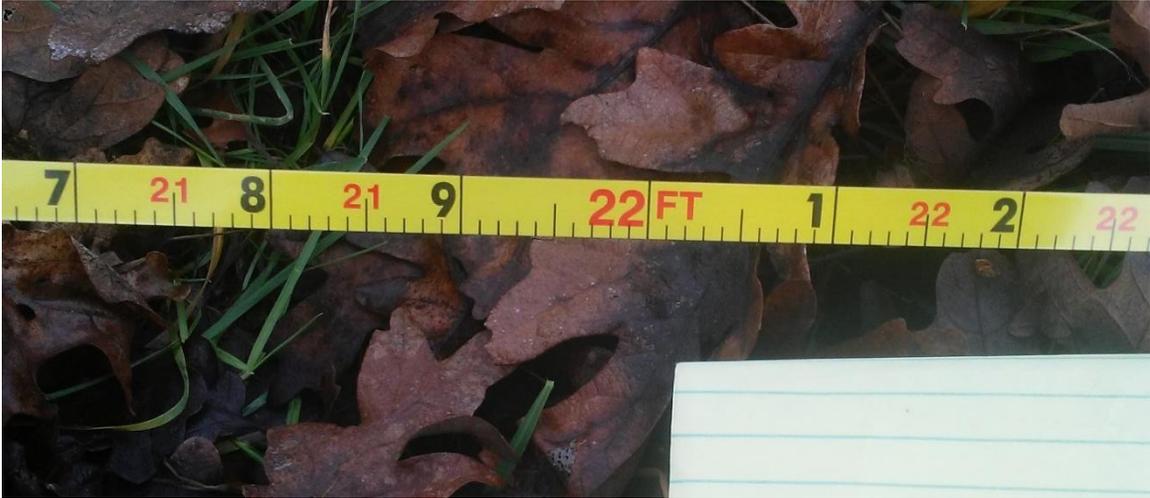
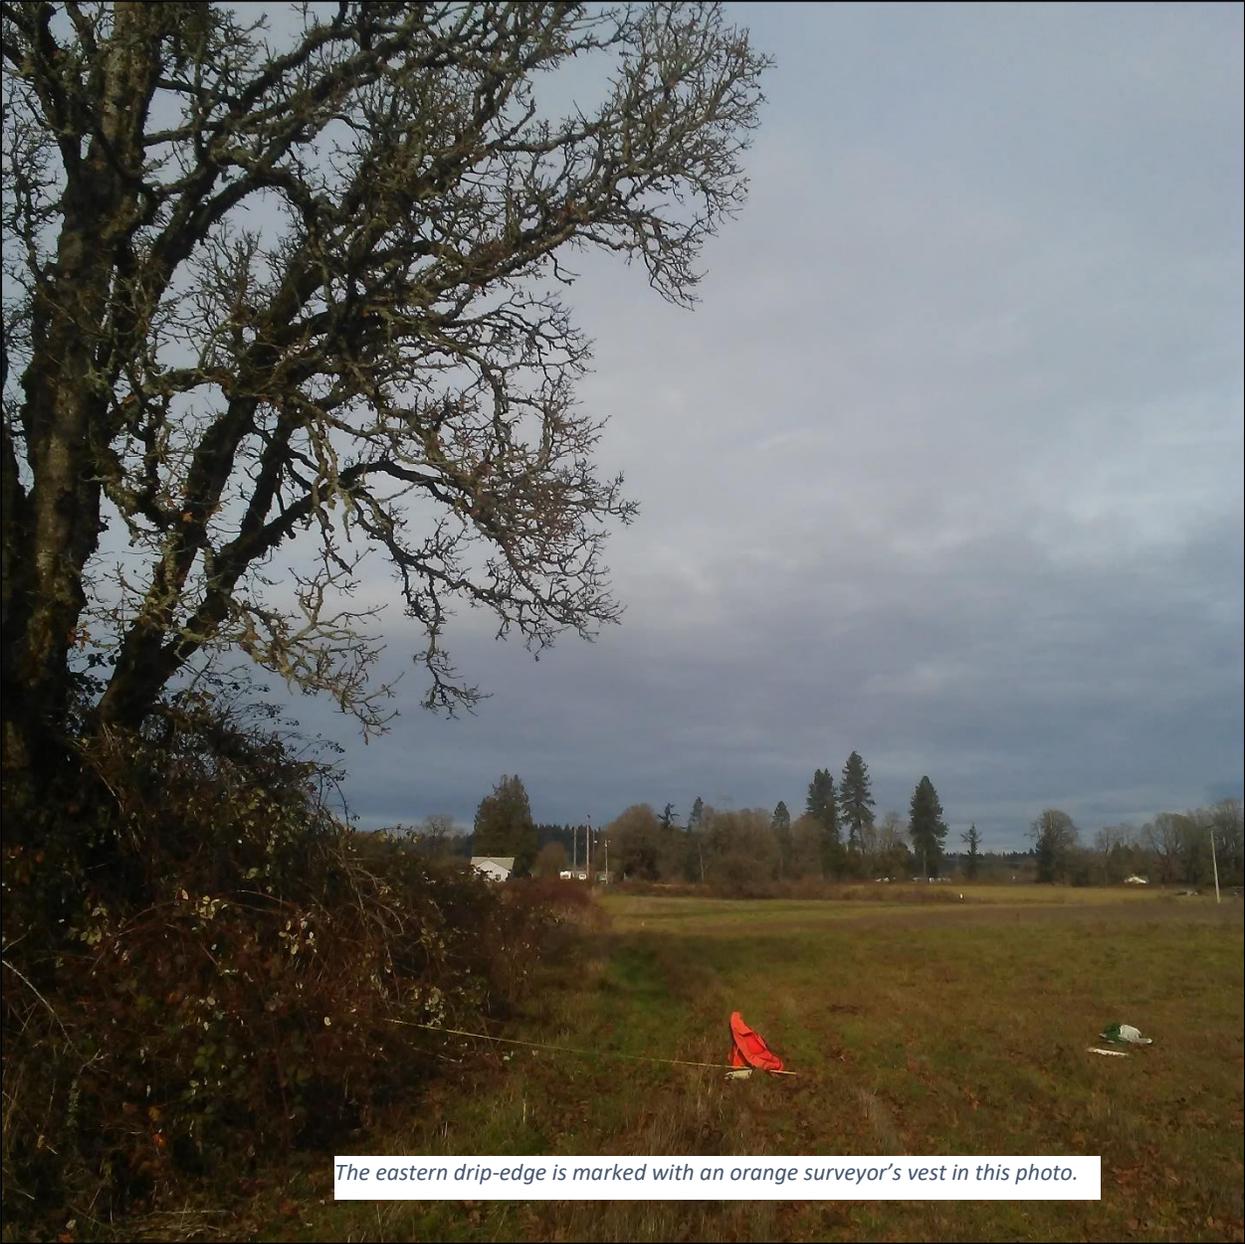
*Cutting through the overgrowth of blackberry was necessary to take precise measurements.*

*The eastern drip-edge is marked with an orange surveyor's vest in this photo.*

It is crucial that the native grade inside the assigned RPZ of T56916 be preserved to avoid injury to the root system and improve survivability during construction. For this reason, I recommend that the blackberry be cut to the ground using hand held tools such as weed trimmers or chainsaws. A hydraulic mowing or brush mulching attachment on a piece of equipment must not be used. This type of equipment will disturb the grade and potentially damage the root system or the trunk of the tree. The blackberry removal can be done pre-construction or post-construction. I also recommend pruning the tree to clean the crown of dead branches and raise the eastern crown to 12 ft. over the future road. Most of the eastern side of the tree is already about 15 ft. high, so only minor pruning will be needed to gain appropriate clearance over the road.
